# PIC16F627A/628A/648A

## PIC16F627A/628A/648A Rev. A Silicon/Data Sheet Errata

The PIC16F627A/628A/648A parts you have received conform functionally to the Device Data Sheet (DS40044E), except for the anomalies described below.

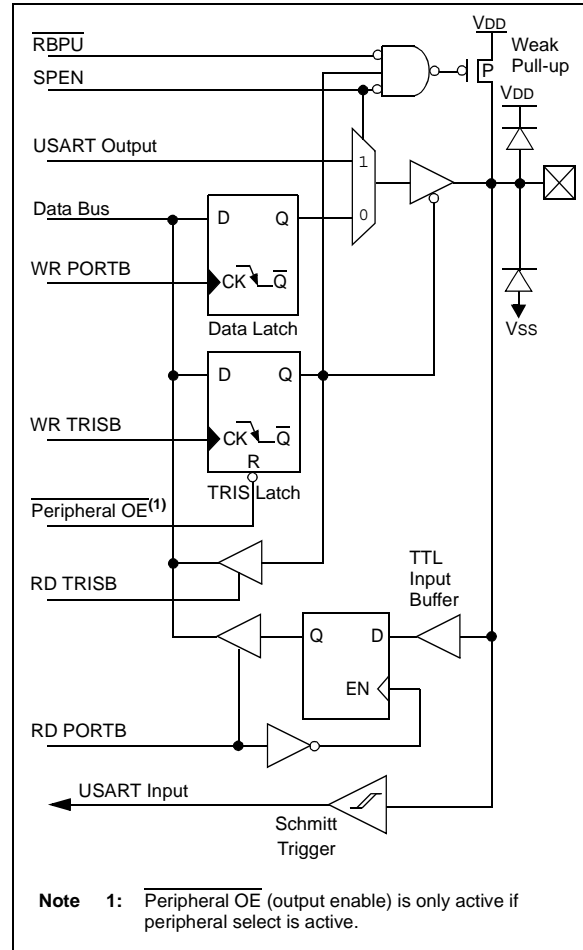
FIGURE 1: BLOCK DIAGRAM OF RB1, RB2

1. USART control of the RB1/RX/DT and RB2/TX/CK differs from the data sheet. Figure 5-9 and Figure 5-10 indicate that the USART circuit overrides the output drivers via the Peripheral OE signal. In fact, the Peripheral OE signal forces the TRISB<2:1> to an output (Reset) state (see Figure 1). Subsequently, the TRISB<2:1> must be set or configured to receive data.

In Asynchronous mode, when transmit is enabled (TXEN = 1 and SPEN = 1), the TRISB<2> latch is cleared to '0' by the USART peripheral circuitry. When disabling transmit (TXEN = 0), the TRISB<2> bit should be set to '1' to configure the RB2/TX/CK pin as an input.

In Synchronous mode, when changing from transmit to receive, clear the TXEN bit first, then set TRISB<1> to '1' to configure the RB1/RX/DT pin as an input before setting SREN or CREN to receive.

When disabling the USART (SPEN = 0), TRISB<2:1> should be reconfigured for input or output as required by the application.

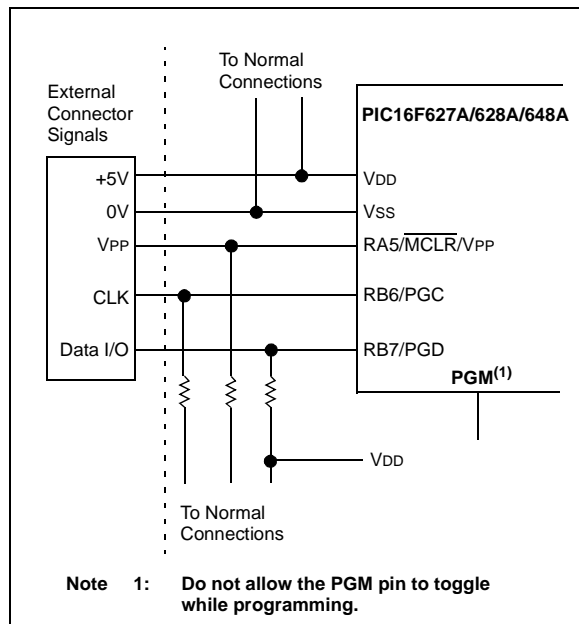
**FIGURE 14-18: TYPICAL IN-CIRCUIT SERIAL PROGRAMMING™ CONNECTION**

Section 14.11: In-Circuit Serial Programming and Figure 14-18: Typical In-Circuit Serial Programming Connection. The following paragraph and Note box are being added to the end of Section 14.11 and Figure 14-18 is updated to include PGM, noted in bold.

If LVP is not being used for programming, but the LVP Configuration bit is set (or LVP feature is enabled), the PGM pin must not be allowed to toggle while programming. The PGM pin is edge sensitive and if an edge is detected during programming, it may cause the PC to reset. If the LVP feature is disabled, the PGM pin will have no effect on programming.
