# PIC16F627A/628A/648A

## PIC16F627A/628A/648A Rev. A Silicon/Data Sheet Errata

The PIC16F627A/628A/648A parts you have received conform functionally to the Device Data Sheet (DS40044E), except for the anomalies described below.

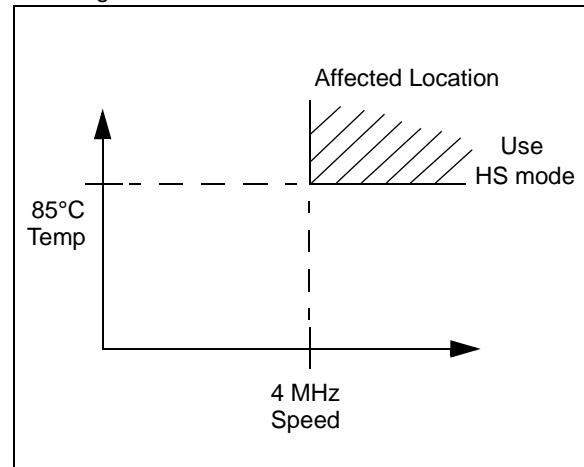
When using the EC OSC mode at frequencies >4 MHz and temperatures >85°C, the part may execute incorrectly from the program memory, causing malfunction.

This problem only affects E-temp parts. Industrial grade parts are unaffected. HS mode should be used for frequencies >4 MHz at extended temps. All other clock modes work to their specified ranges.

**Note:** This problem is corrected in PIC16F648A Rev. A3. (Date code 0420XXX and later).
